Defective Chinese Drywall: Analytical Testing

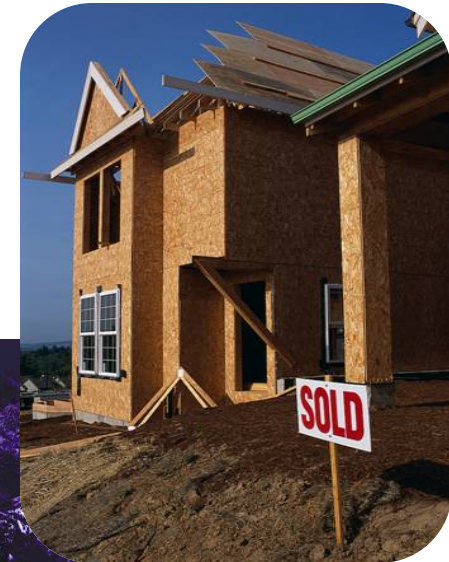
Definition of Problem

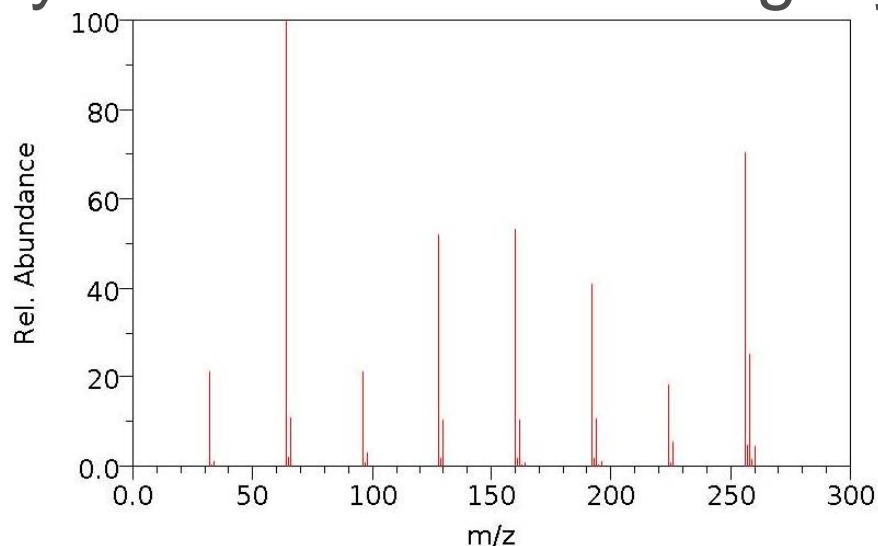
Elemental Sulfur
